Summary Test Results SunBrush mobil

Test 1- 2010: SunBrush mobil – Standard Cleaning

Test 2 – 2015: SunBrush mobil – Soiling with Sand

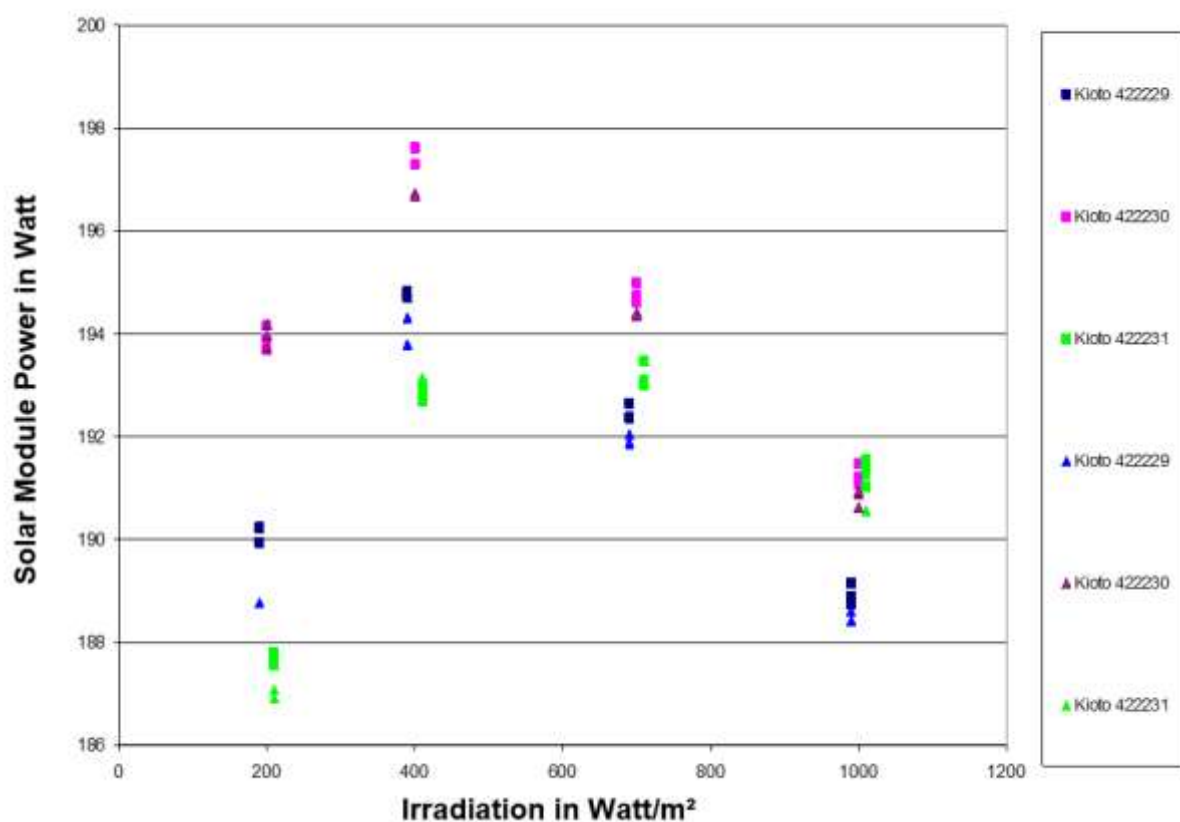
Figure 1: Results of the module power measurement at different irradiation levels before and after the 4338 cleaning cycles.

The square mark shows the three modules before the test run. The triangle mark shows the power measurements after to the test run. Three power measurements were carried out at each irradiation and each module. The difference between the measurements before and after the test run was +0.1 to -0.3%.

The absolute accuracy of power measurement is +/- 3%. The accuracy of the repeated measurement is 0.25-0.5% of the measured value.

The results of performance measurements were confirmed by the optical surface analysis of the modules.

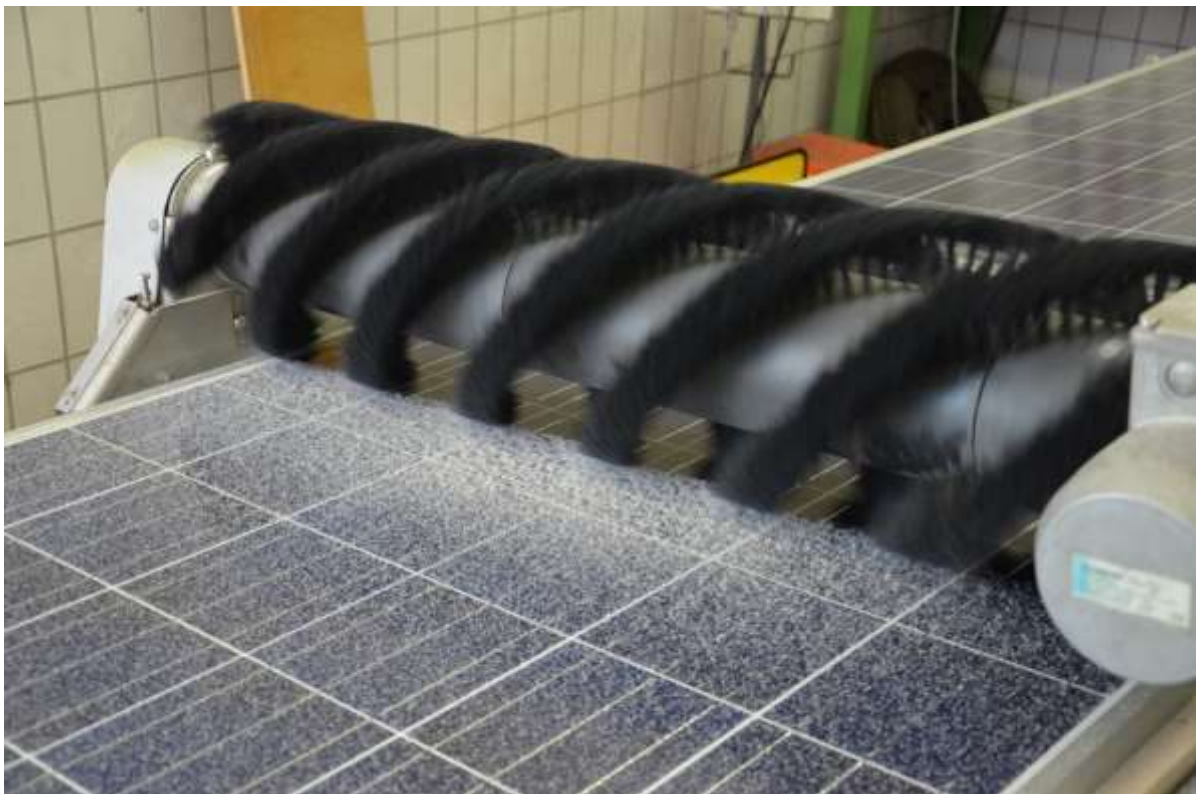
Figure 2: Dry cleaning process with the SunBrush mobil cleaning unit.
